CRIGLERSVILLE SCHOOL – VOTING BUILDING

Madison County, Virginia
Capital Improvements Program

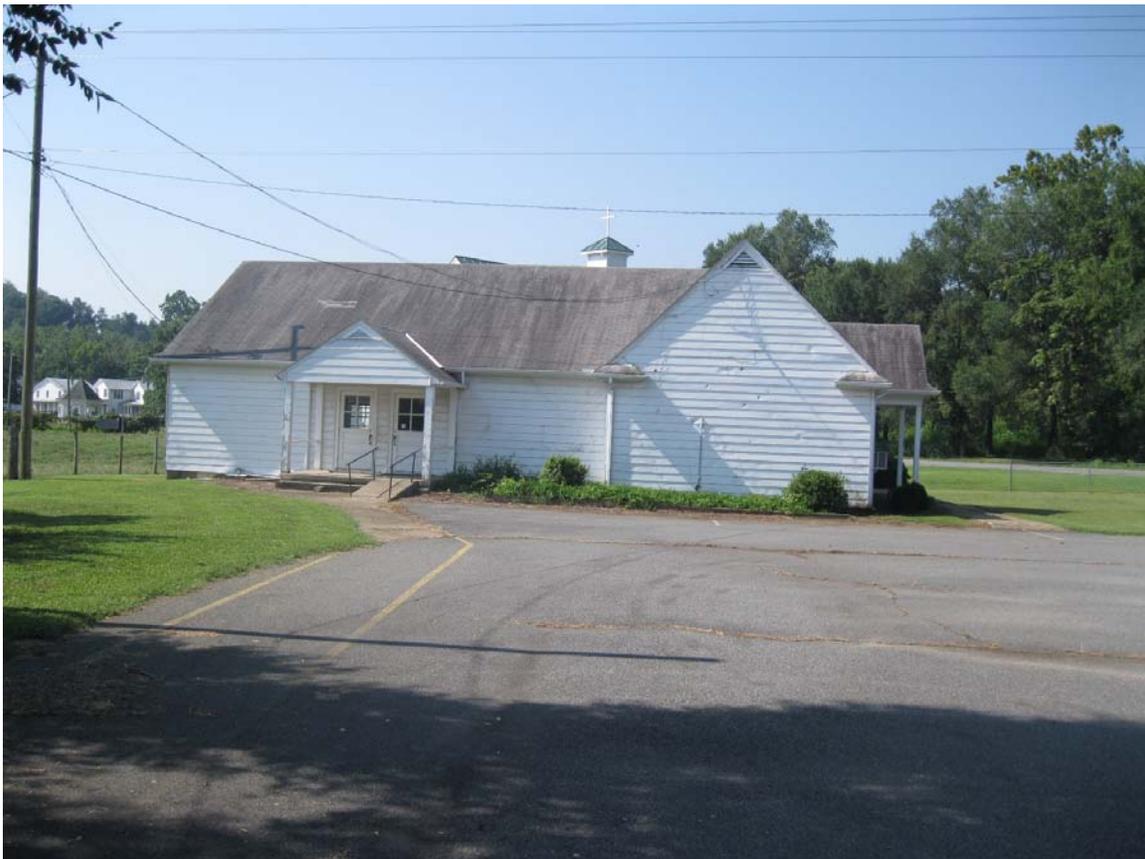
The date of construction is unknown for the single story, aluminum sided wood framed dwelling was constructed in the early to mid 1900's and has been used primarily as a residence and also as a residence to house various employees of the school after it was constructed in 1949. Most recently it is used by the county as a polling place during local and state elections for citizens in this area of the county, and also as a storage area for the county.

Aluminum siding over original wood siding and wood frame. Interior walls are wood paneling probably over existing plaster walls, but not verified. Original windows are single pane wood double hung with aluminum storm/screens. The windows should be scraped and repainted due to potential lead paint that is peeling. Re-glazing may also be required. Sash operability as well as operations of the storm/screen system should be evaluated and repaired as required to limit energy loss. All exterior trim should be checked for rot and replaced as necessary prior to scraping and repainting. There are some small areas of rot in the porch roof trim.

Asphalt shingle roofing that needs to be replaced. All flashings at valleys should be replaced to prevent roof leaks. Replace missing downspouts and verify that existing gutters are securely fastened to the structure and positively drain.

- Scrape and repaint all exterior trim – suspected of containing lead paint. Replace damaged, or rotted components.
- Replace interior carpet and VAT floor tile.

- Replace missing downspouts to conduct rain water away from structure.
- From a system standpoint the heating system, believed to be baseboard needs to be tested as it was not operational at the time of assessment.
