CRIGLERSVILLE SCHOOL BUILDING

I. Facility Description

The Criglersville elementary School is a two story brick masonry building originally constructed in 1946 - 1948. The facility has not been used as a school for approximately 10 years. In recent years, the facility was used as a community center with small library and table games on a limited basis. The facility has been closed for the past 5 years. There have been recent reports in regards to the facility done completed in 2002; the site and adjacent structures as recent as 2010. The exterior masonry is general in fair condition; the windows are single pane, steel type with fixed and operable units and are original to the building. The building and site pose numerous challenges to re-use or change in use of the structure.

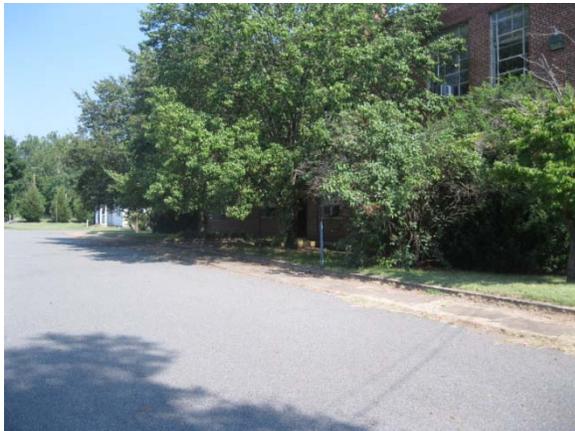
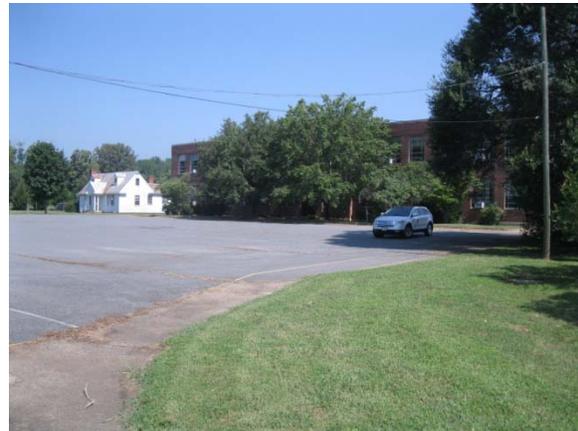
Early in the construction of the school there was a wood framed entry that was destroyed in a fire and not rebuilt. Since then, there have been no documented renovations besides interior finishes have been completed.
